**Laguna de Santa Rosa  
Historical Hydrology Project  
Headwaters Pilot Study**

**FINAL REPORT**

Arthur Dawson, Historical Ecologist  
Sonoma Ecology Center

August 2010

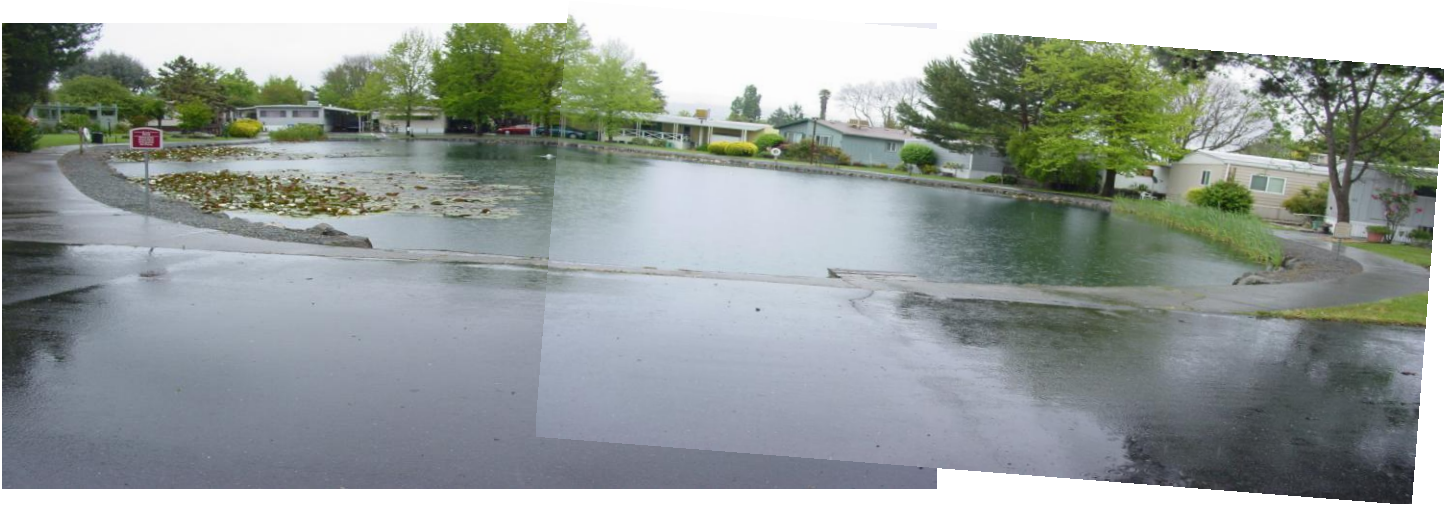
**Figure 4.** Spring-fed lake, Las Casitas de Sonoma Mobile Home Park,  
7545 Bridgit Drive, Rohnert Park.  
Photograph by Arthur Dawson, May 10, 2010.

**Presence of Seasonal and Perennial Lakes:** Two mid-19<sup>th</sup> century maps (U.S. District Court c. 1840; Bowers 1867) show the Laguna's southernmost perennial lake. Rectifying the Bowers (1867) map with the current topo for the project area (USGS 1980), showed that a small remnant of this lake might still be there. A field visit confirmed that a remnant of this lake still exists within the Las Casitas de Sonoma mobile home park at 7545 Bridgit Drive, Rohnert Park, just off the Laguna's modern main channel. The lake is described in the mobile home park's literature as "spring-fed" (Blaker 2010) and, while modified, appears to be a natural feature (Figure 4).
